TRAFFIC SAFETY AT PEDESTRIAN ZEBRA CROSSINGS

Long-term research and development programme for road safety

LINTU-Reports 7B/2007

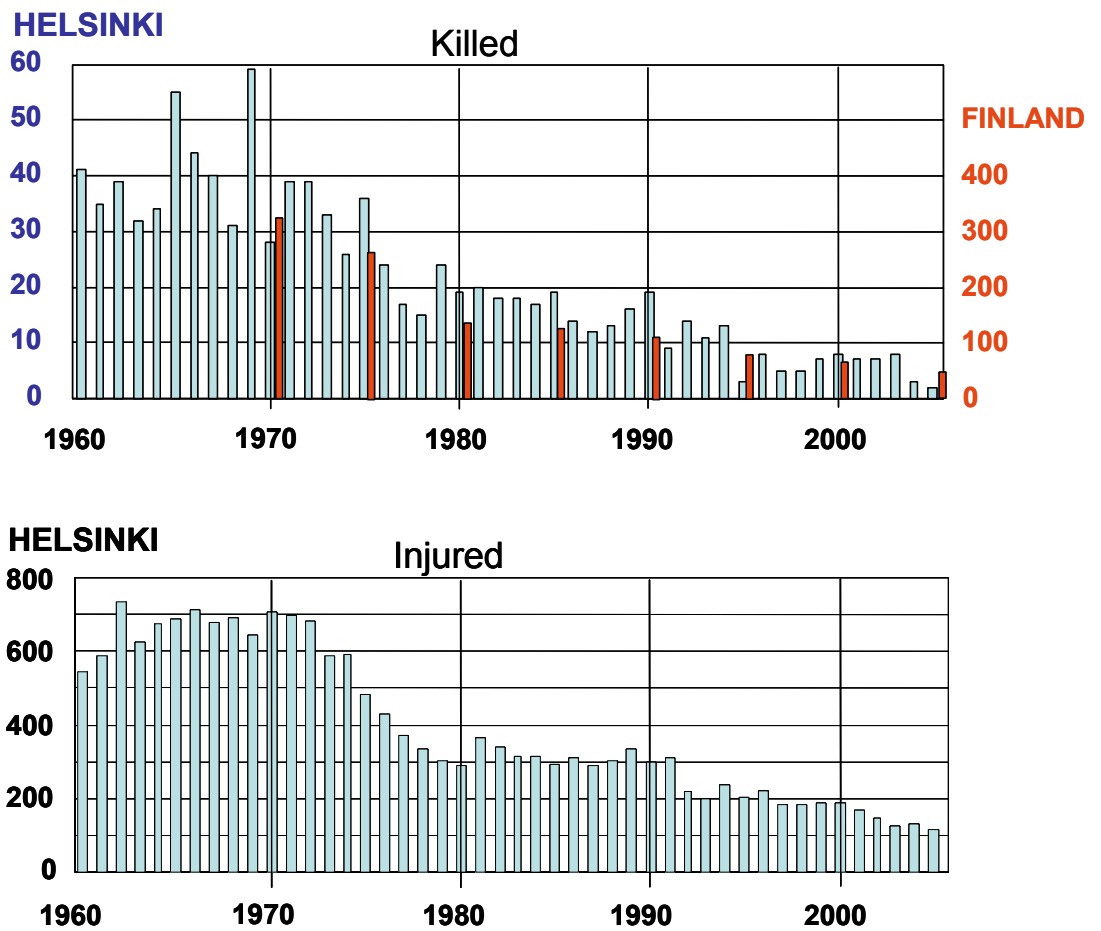
Figure 4: Killed and injured pedestrians in Helsinki in the years 1960-2005.

The radical improvement of pedestrian safety in Helsinki is obviously not caused by painting zebra stripes. We do not even know if zebra stripes have either increased or decreased traffic safety.

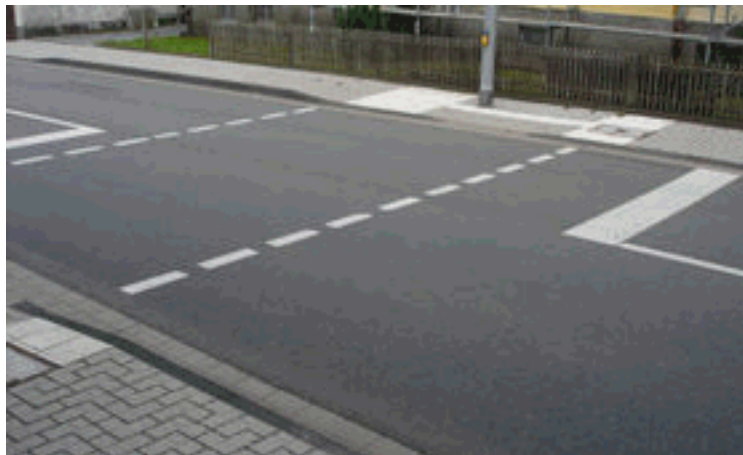
In Germany, signalised crossings are equipped with white broken lines (Fußgängerfurt). They do not give any rights for pedestrians and they are not used outside signalised crossings.

Figure 9: A signalised pedestrian crossing in Germany.

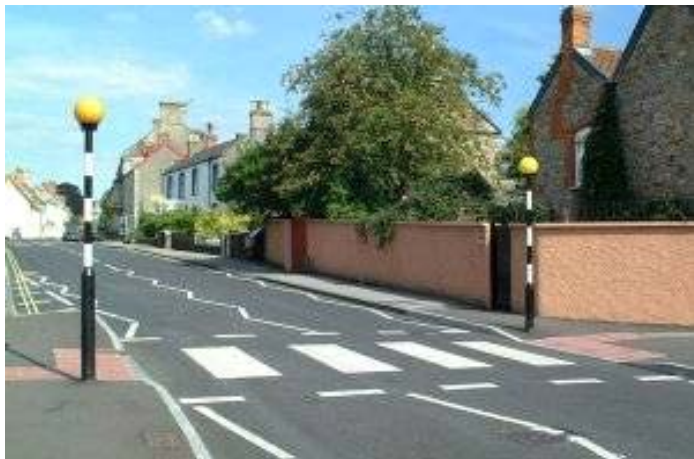
Zebra crossings are equipped with black-and-white poles topped by flashing orange globes. The zig-zag lines before the crossing forbid parking and also overtaking a moving vehicle nearest the crossing or a vehicle which has stopped to give way to pedestrians.

Figure 10: A British zebra crossing.

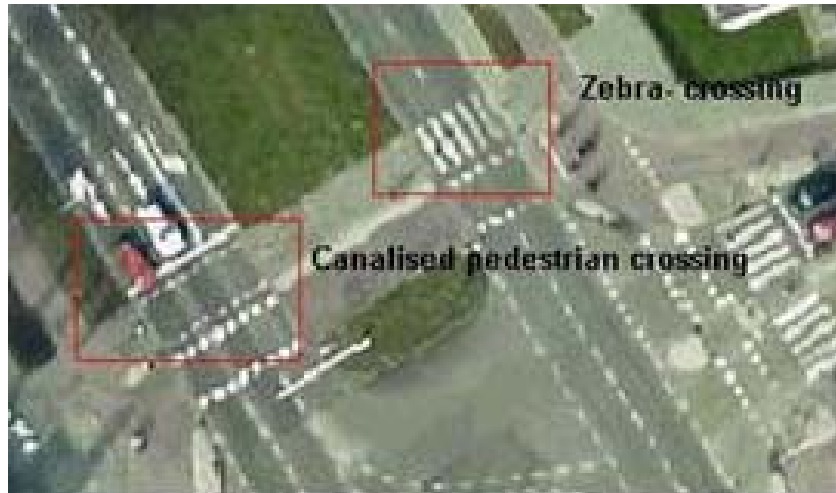
Figure 12: Zebra crossings and a canalised crossing at a same junction in Eindhoven.

In the City of Eindhoven, new zebra crossings have not been painted since mid nineties. They are considered to give pedestrians a false feeling of safety. Canalised pedestrian crossings – which do not give any specific rights for pedestrians – are preferred.

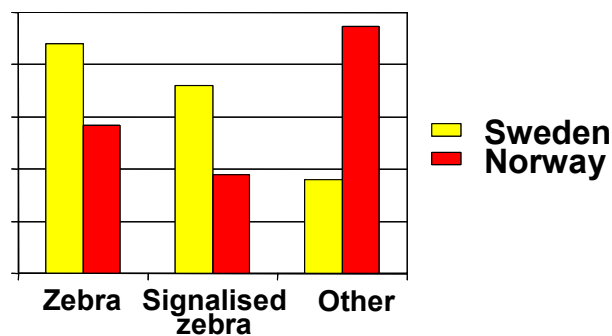
Figure 13: Accident risks at different crossing facilities in Sweden and Norway.

Swedish research shows that a zebra crossing is the most dangerous place to cross a street for pedestrians. The Norwegian results were controversial with this finding /3/.

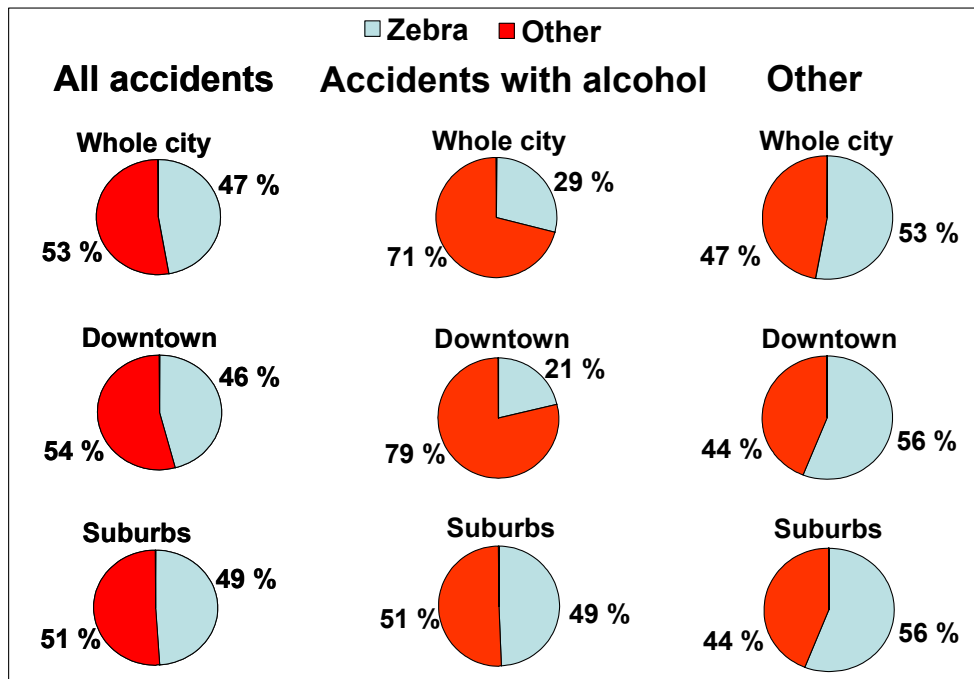
Figure 16: Pedestrian crossing accidents outside signalised crossings.

It is difficult to estimate the share of pedestrian crossing incidents at and outside signalised crossings. Figure 16 shows the accident distributions if signalised crossings are excluded.

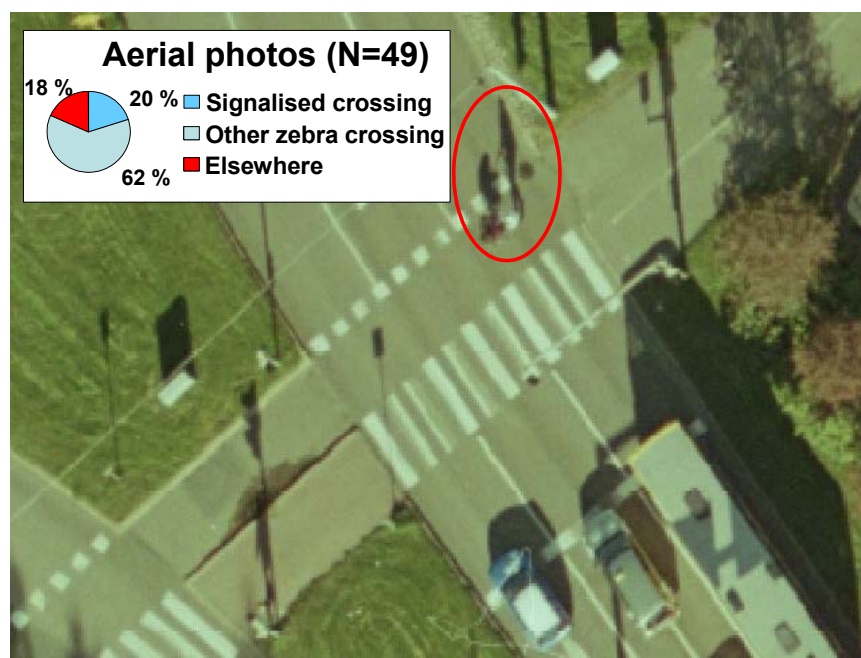
Figure 17: Distribution of pedestrian crossing events in suburbs.

A data set of aerial laser photos with a ground resolution of 5 cm covers all of Helsinki. However, the calculations had to be limited to totally sunny street surfaces where the shadows of pedestrians confirm the identification. In addition, streets without footpaths had to be excluded, because it was impossible to know if the pedestrian was walking along or across the street.

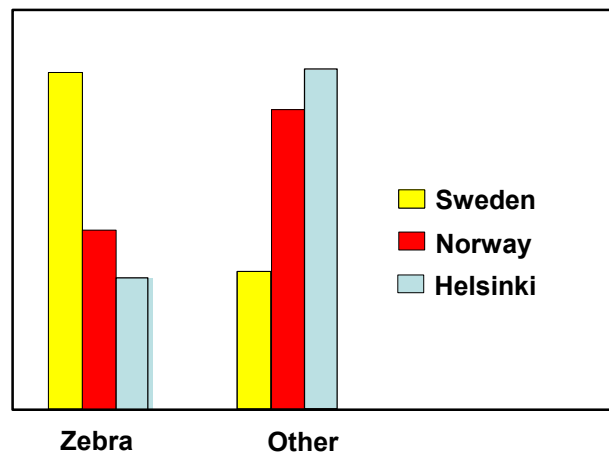
Figure 20: Relative accident risks outside signalised crossings according to calculations in Sweden, Norway and Helsinki.

Outside signalised crossings, about 55 % of pedestrian accidents in Helsinki take place at zebra crossings. The share of pedestrian crossing incidents at zebra crossings varied between 63 and 92 per cent depending of the place and method of counting. If the average share is estimated roughly to 75 per cent, the risk of crossing a street outside zebra crossings is more than double compared to non-signalised zebra crossings.

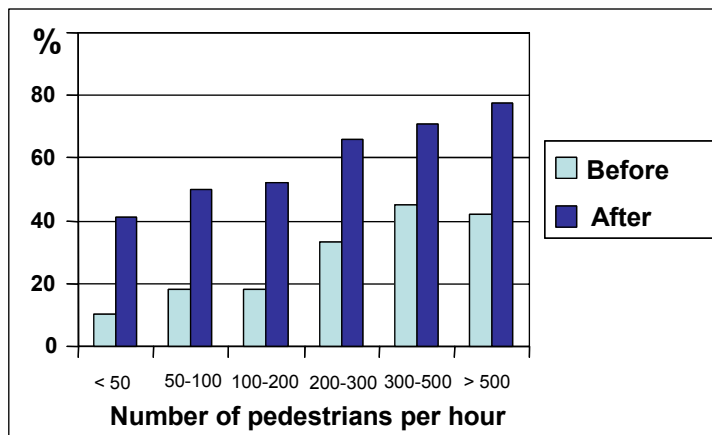
Figure 21: Cars that stopped or adjusted their speed to give way to pedestrians on the crossing (nearest lane) before and after 1 May 2000 /4/.

The proportion of vehicles which stopped for pedestrians increased from 20 to 50 per cent. The proportion has a high degree of co-variation with the number of pedestrians.

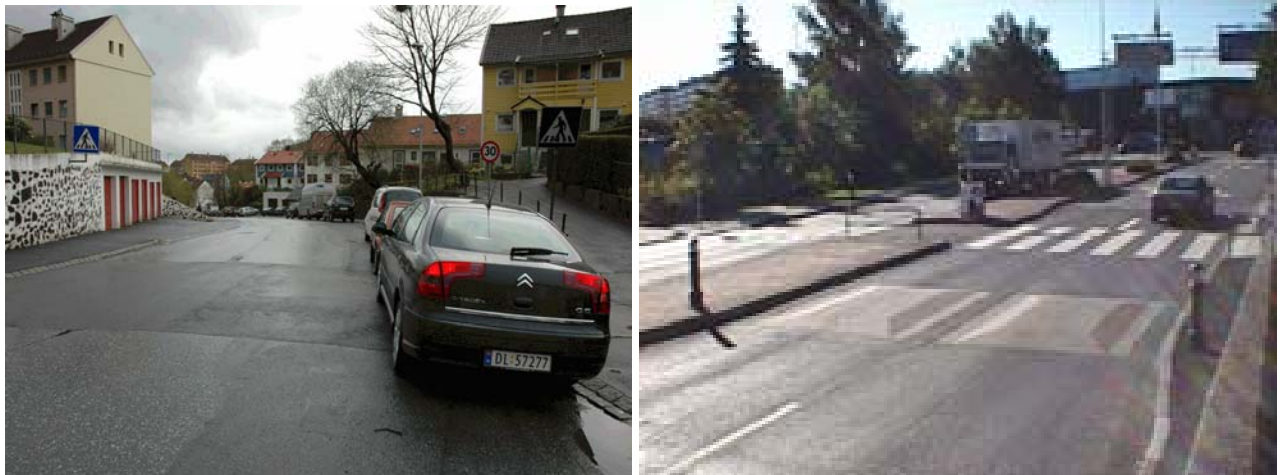
A concrete element with a shape of a cut pyramid treats buses and emergency vehicles with wider axles more gently. A concrete element is rather expensive compared to an asphalt hump but it maintains the exact shape and it can also be equipped with tough reflective warning symbols.

Figure 32: A hump of asphalt in Bergen and the Swedish concrete element (Måsen).

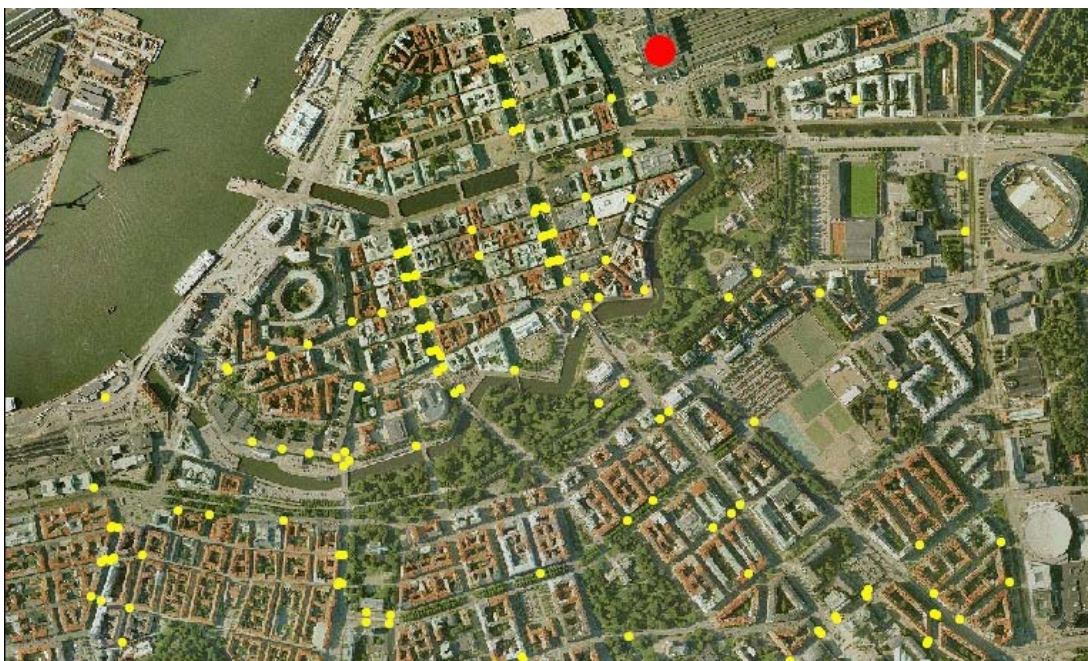
Figure 33: Elevated pedestrian crossings in downtown Gothenburg.

The present humps in Helsinki are mostly located in suburban streets with low traffic volumes. The Swedish City of Gothenburg has introduced elevated pedestrian crossings on a large scale also on more busy downtown streets.

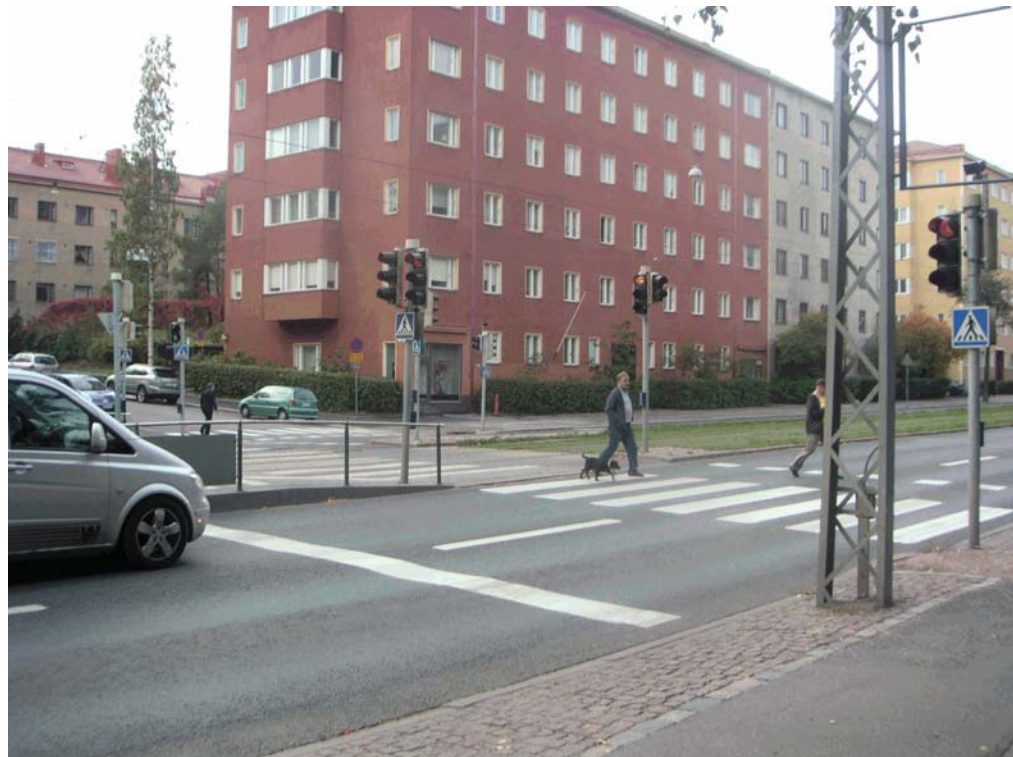
Figure 37: A recessed stop line at a signalised zebra crossing in Helsinki.
